REFURBISHMENT STRUCTURAL STRENGTHENING WITH SIKA SYSTEMS

FOR OWNERS OF BUILDINGS AND CIVIL ENGINEERING STRUCTURES

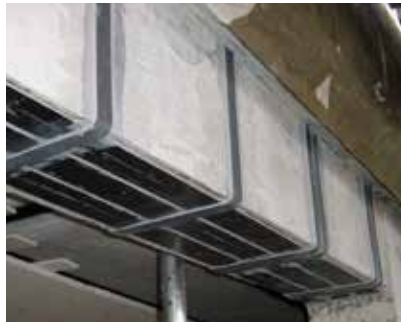
BEAM STRENGTHENING

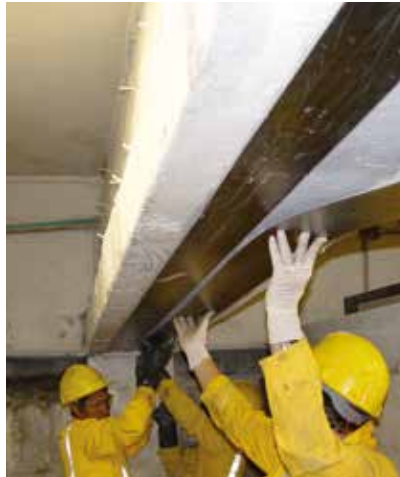
The Sika CarboDur® System is the most widely recognized and established carbon-fiber-reinforced polymer (CFRP) strengthening solution available worldwide. It consists of Sika CarboDur® CFRP plates and rods, together with the structural epoxy resin based adhesives Sikadur®-30 and Sikadur®-30 LP. This simple, tested and well proven, highly durable system has outstanding performance. With the Sika CarboHeater curing times can be accelerated and down time minimized, even at lower temperatures.

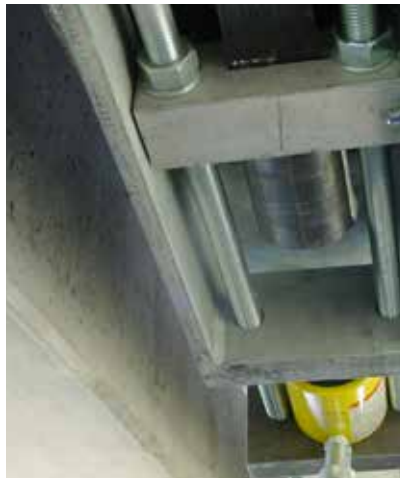
Post-tensioning: a force is applied to create permanent stress in a structure, so that it can withstand load more efficiently or with less total deflection. In conventional post-tensioning, the load is put on steel tendons within the concrete structure, however with the Sika CarboStress® system, the advantages of the Sika CarboDur® CFRP plates and post-tensioning techniques are combined to form a unique active external strengthening solution.

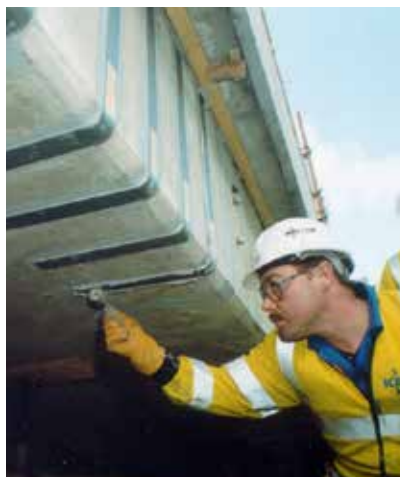
The shear capacity of concrete beams can be increased by the external applied Sika CarboShear L-shaped profiles. Installation is fast and easy, excellent anchorage is assured and no drilling through the top slab is required.

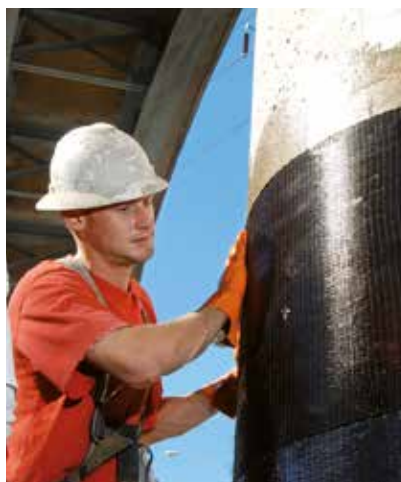
The SikaWrap® fabric strengthening system consists of woven or stitched, unidirectional, carbon and glass fibre fabrics and Sikadur® impregnating resins. This system provides a wide range of solutions to meet different demands on many different types of projects. The installation is extremely flexible and accommodating of different surface planes and geometry, making this a very multi-functional material for many applications including confinement, shear, seismic upgrading and weak substrate strengthening.

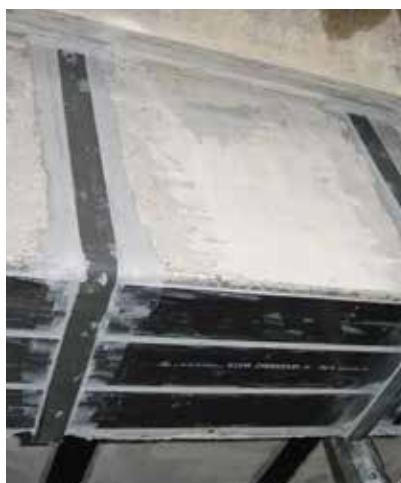
The combination of all of the different Sika Strengthening Systems is possible and allows unique solutions to be engineered, especially for:

- Shear and flexural strengthening
- Enhanced end anchorages

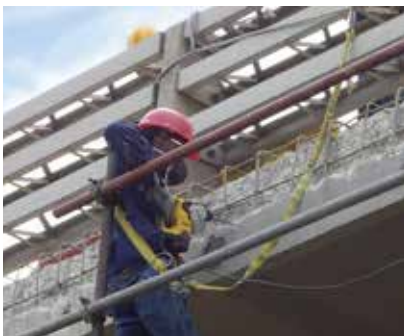
Substrate preparation

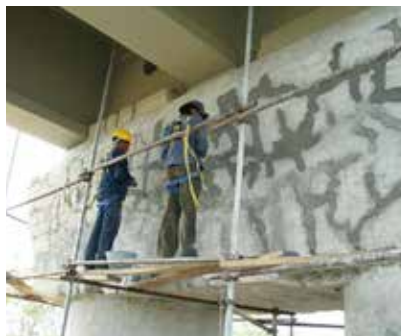
Repair

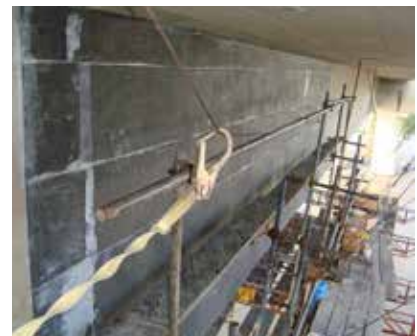
Strengthening with SikaWrap®

Few years after the initial concrete repair works were completed shear cracks were noticed in the beams and the requirement for structural strengthening was decided by the Engineers. After sealing and filling the cracks with Sikadur® injection resin, the substrate was prepared and a lightweight SikaWrap® fabric strengthening system was applied in two directions and finally the areas were covered with a SikaTop® coating.

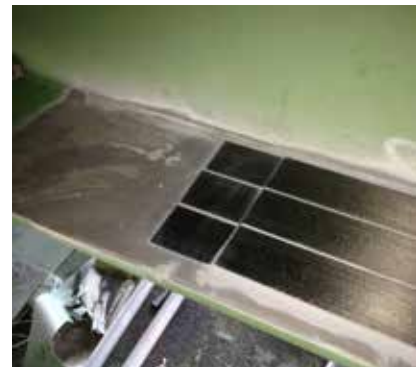
Two layers of Sika CarboDur®

CarboDur® system. After the steel substrate was cleaned and prepared by abrasive blast cleaning, the prefabricated CarboDur® CFRP plates were then immediately bonded to the steel surface with Sikadur® structural adhesive. With these strengthening measures, the mechanical characteristics of the structure were increased and the amplitudes of stresses due to movement were reduced; thus the service life of the bridge was significantly extended. This was the first experience in France of strengthening this type of structure with bonded CFRP.

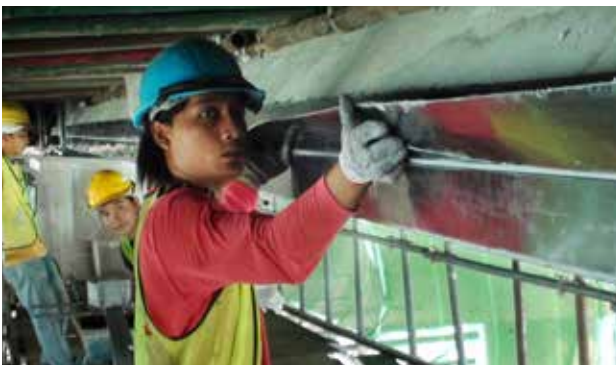
Installation CarboDur®

Engineers, using a layered build-up of the Sika CarboDur® CFRP System. Finally, all of the exposed concrete and CarboDur® plate surfaces were given a protective Sikagard® coating to protect them against UV light and future attack from the aggressive marine environment respectively.

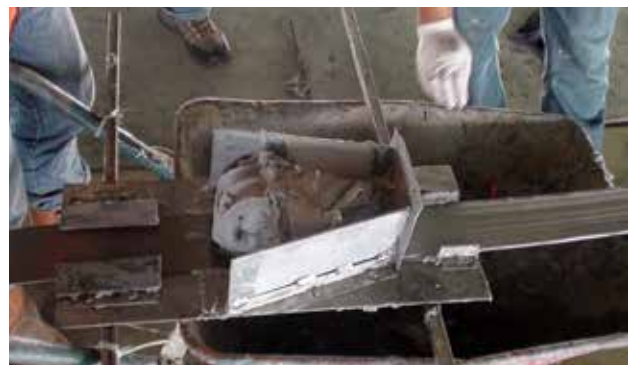
Coating of CarboDur® plates with Sikagard®

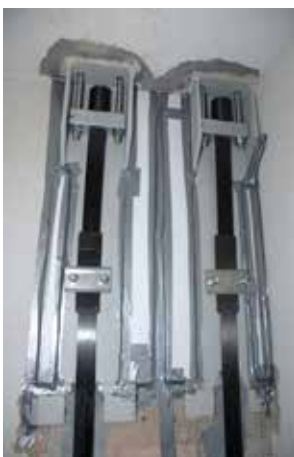
Anchorage of Sika CarboStress System

The Sika CarboStress® system was selected to achieve the necessary seismic resistance on the structure. This consisted of post-tensioned Sika CarboDur® CFRP plates anchored into the substrate. In the three stairwells of the building, a total of 12 Sika CarboStress® tendons were installed. Since these Sika CarboStress® tendons were relatively small, flexible and could be

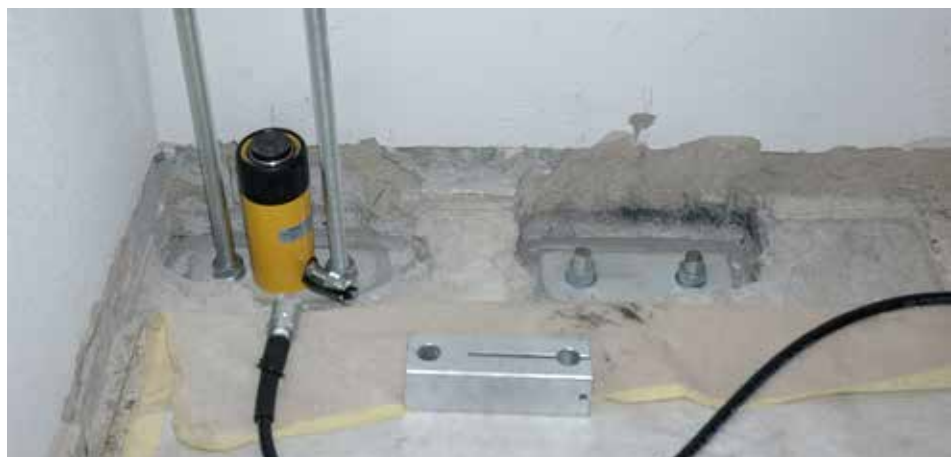
Pressure cylinder

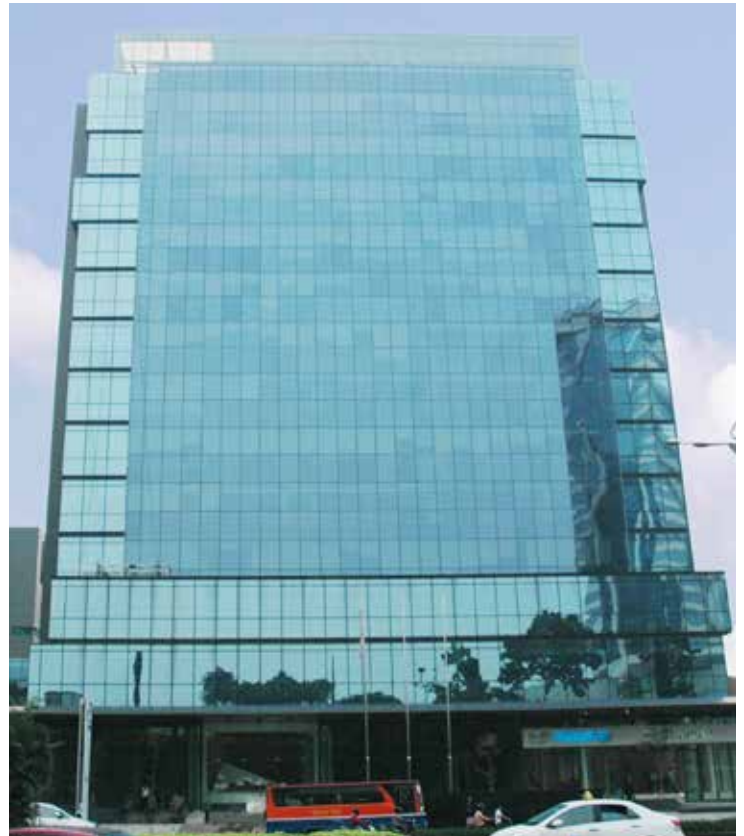
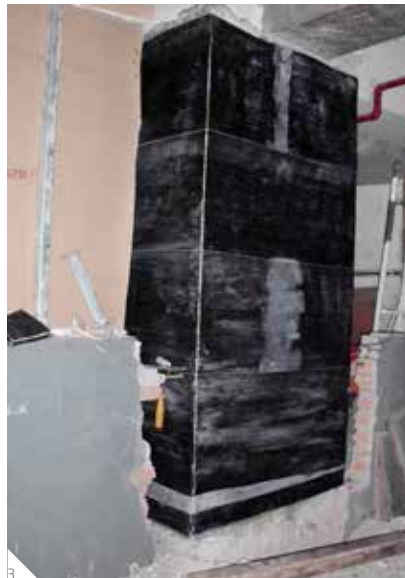
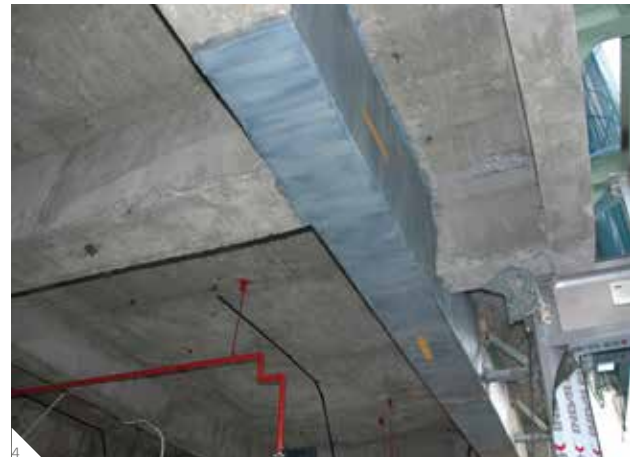
- 1 Beam strengthened without removing wall
- 2 CFRP installed around existing obstacles
- 3 Columns strengthened with SikaWrap® fabric
- 4 Reinforcement of beam with CFRP

The Engineers selected a Sika structural strengthening solution with carbon fiber-reinforced polymer (CFRP) materials, because of its effective performance despite its lightweight characteristics. Furthermore, the Sika systems allowed flexibility on site to overcome any issues and were easy to apply. The columns in the basement and ground floor were strengthened to provide increased confinement with the SikaWrap® fabric strengthening system. The cross beams were then either strengthened in flexure and against shear, or against shear only, by using a combination of Sika CarboDur® CFRP plates and SikaWrap® fabrics, with up to three layers of the fabrics being applied. During the installation works on site unforeseen conditions, including walls that could not be removed and voids in the existing concrete, were found. Another advantage of these Sika strengthening solutions was then that their design can be adjusted accordingly, so the works could still be completed successfully and with minimal break-out or removal of sound materials on site.

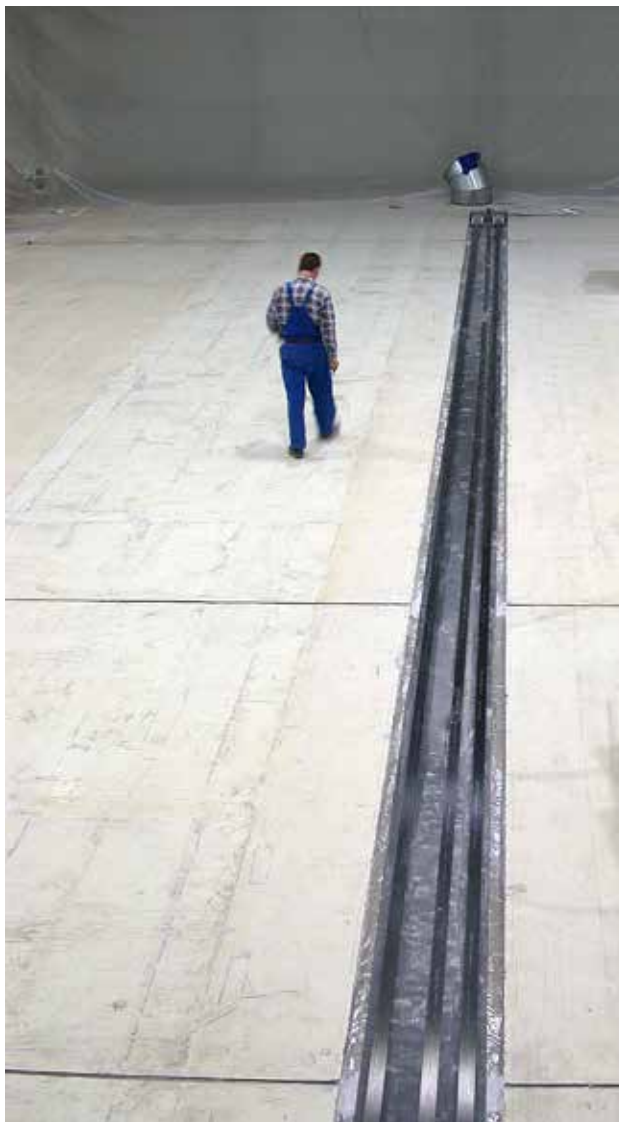
The longest post-tensioned CFRP-plates ever installed

With 29 m this is the one of the longest post-tensioned CFRP plates ever installed in the world.

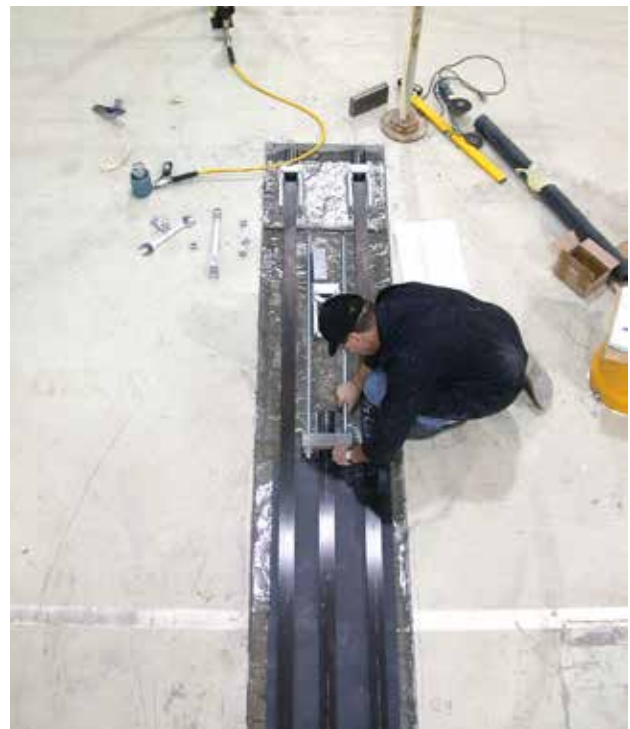
Plate and end-anchorage

System. Three tendons, consisting of CarboDur® plates and special end anchorage heads were installed to produce a united base without joints. The CFRP plates were then encapsulated into the concrete base to protect the system and to make the area ready for use.

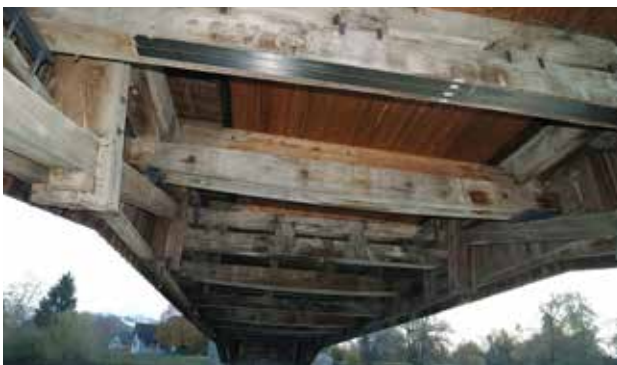
CarboDur® strengthened crossbeam

To refurbish the bridge the deck was removed and rebuilt, and Sika CarboDur® CFRP plates were bonded to the bottom of the crossbeams to reduce deflection. The installed plates were left exposed and uncoated to facilitate inspection and assessment, but to date the installation remains maintenance free.

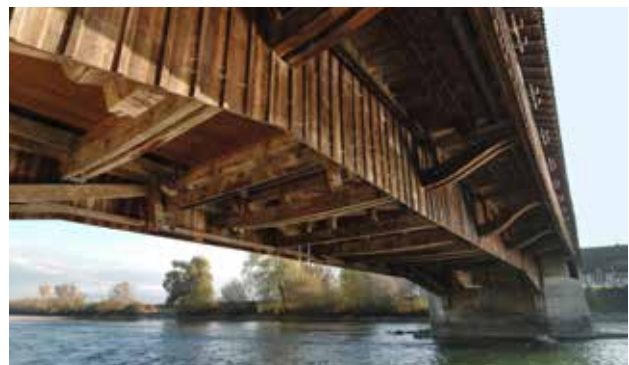
Bottom view of strengthening system

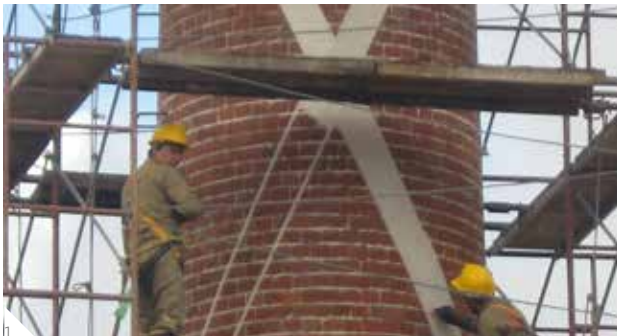
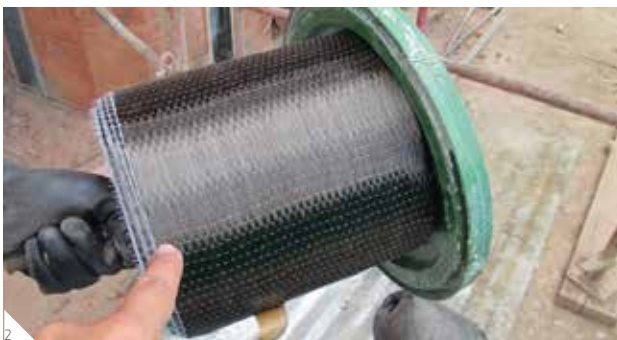
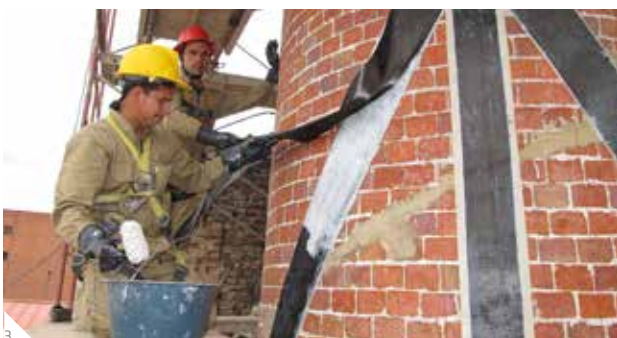
- 1 Substrate levelling
- 2 SikaWrap® roll
- 3 Installation of SikaWrap®
- 4 Coated strengthening system

A complete Sika solution was selected. After cleaning the structure thoroughly, Sikadur® epoxy mortar was applied to level the surfaces and prepare them for application of the SikaWrap® fabric strengthening system. SikaWrap® fabric strips were then cut to size and applied symmetrically, both diagonally and vertically, to improve the strength of the whole chimney structure with a uniform appearance. Finally the whole masonry chimney surfaces were overcoated with an acrylic protective coating.
