# CAR PARKS REFURBISHMENT

# MEETING YOUR NEEDS ON EVERY LEVEL

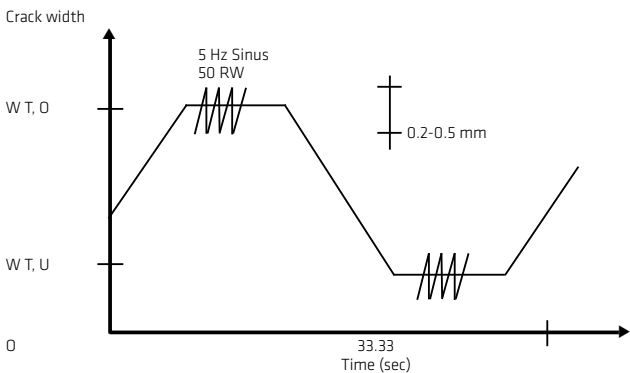
## Example of test method used to determine crack bridging properties: (EN 1062)

System: OS-11  
Classification: II T+V, dynamic  
W T, O = 0.50mm upper crack width  
W T, U = 0.20mm lower crack width  
 $\Delta W V = 0.30mm$  change of crack with through traffic

Note: the graph is showing 1 cycle, the tests involves a total of 20,000 cycles @ -20°C

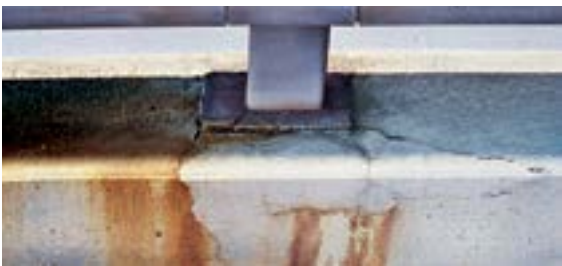
### MOVEMENT

- Ground movement or movement of the structure or of individual components, eg at construction joints, expansion joints is usually visible. Parking structures in use are always subject to dynamic loading

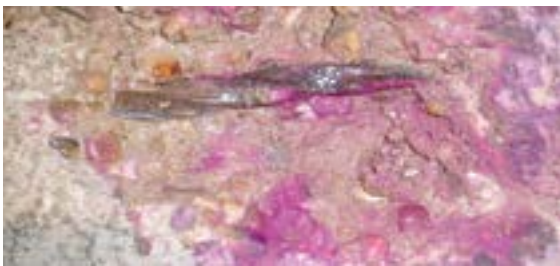
### ATMOSPHERIC CARBONATION

- Atmospheric carbon dioxide gradually and progressively reduces the protective alkaline layer around the reinforcement, which will allow the steel to corrode

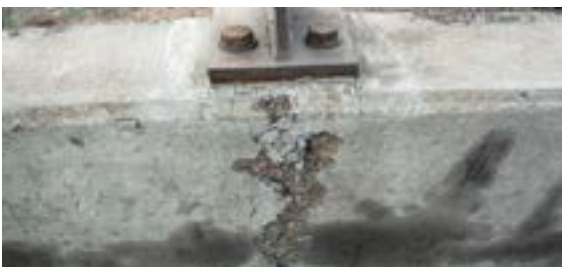
### THERMAL VARIATIONS

- Sunlight causes thermal expansion and stress cracking
- Frost causes thermal contraction and freeze / thaw damage
- Ultraviolet light causes degradation of organic materials, ie waterproofing membranes, resin and coatings

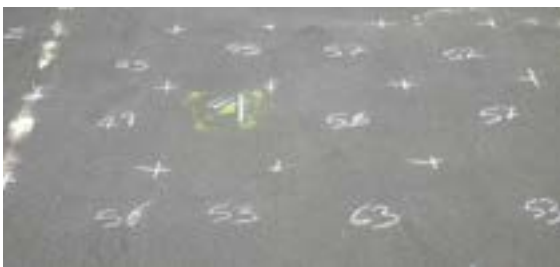
### DE-ICING SALTS

- De-icing salts are based on chlorides. The penetration of water contaminated by de-icing salt into concrete cause corrosion of embedded steel reinforcement and often cracking, spalling and delamination of concrete cover

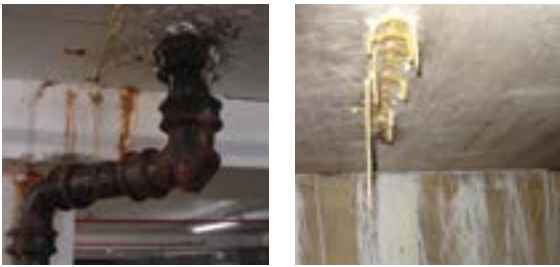
### RAINWATER

- With water filling the pores and capillaries, concrete becomes susceptible to freeze/thaw damage
- In carbonated concrete water ingress will allow steel reinforcement to corrode

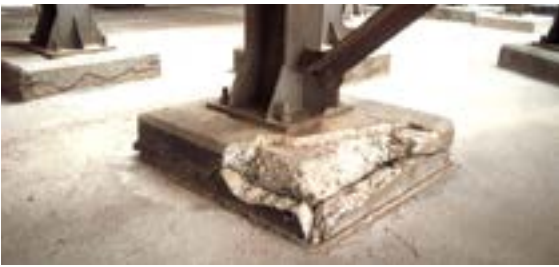
### MECHANICAL EXPOSURE

- The decks of parking structures are exposed to different levels of mechanical stress, according to their location and function, ie:
  - Pedestrian levels: walkways
  - Standard levels: in primary parking bays
  - Heavy levels: entrance and exit areas, ramps and turning cycles

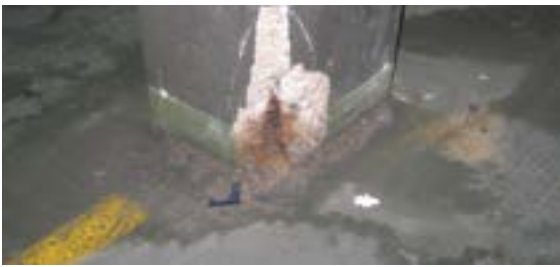
### AGGRESSIVE POLLUTANTS

- Acidic oxide gases of sulphur and nitrogen from exhausts diffuse into the condensation and attack and corrode the concrete surface, which reduces the strength and increases the porosity
- Some liquids, such as hydraulic brake fluid, are very aggressive and will attack concrete and steel surfaces

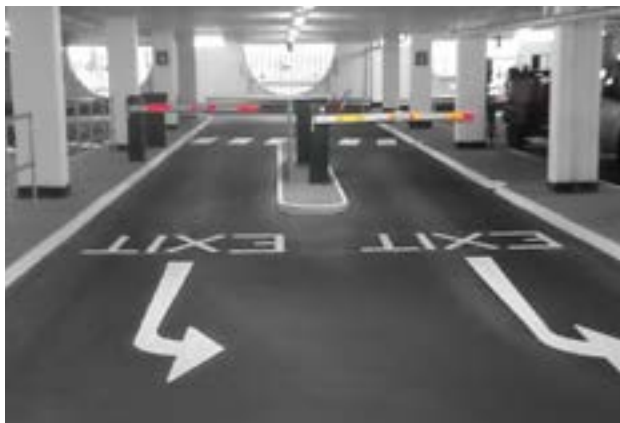
## SIKA HELPS BRIGHTEN BASILDON CAR PARK

The car park was in need of major refurbishment. Continual exposure to chlorides from de-icing salts, carbon dioxide and water penetration, had caused the concrete to spall as the steel reinforcement within had corroded. A repair solution that would inhibit future corrosion taking place was required together with a durable coating and decking system that would ensure the future integrity of the structure.

Sika were able to provide a single source supply for concrete repairs, corrosion management and both deck and soffit coatings. Spalled areas of concrete were removed and soffit repairs carried out using the Sika® MonoTop® system. This one-component system has the advantage of easy handling and application, with high build qualities. Decks were repaired using Sika® Rapid Repair mortar, a cementitious mortar with high early strength, which kept the time out of service to a minimum.

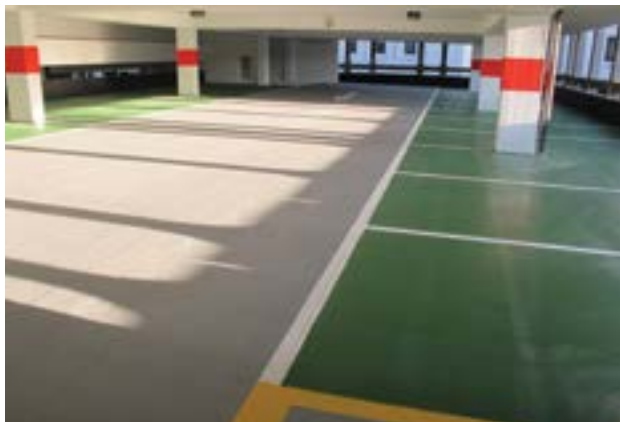
### HIGH CHELMER CAR PARK AGEING CAR PARK GET NEW LEASE OF LIFE

In March 2011, following the discovery of localised instances of concrete spalling due to expansive corrosion of the reinforcement bars, Chelmsford Borough Council acted upon professional advice from the structural and civil engineers to close High Chelmer Car Park and Retail Market to allow significant repairs and a full refurbishment to be completed.

During site inspections it was discovered that the car park required 1,500m<sup>2</sup> of repairs – 50% more than the original figure of 1,000m<sup>2</sup>. It was anticipated that the concrete required repairs to a depth of 75mm, however, on commencement of work this was amended to 85mm.

Sika, offered a full range solution for the concrete repair corrosion management using a combination of Sika® Galvashield® XP2 sacrificial anodes, Sika® Ferrogard®-903 migrating corrosion inhibitor and 120 tonnes of Sika® Armocrete flowable micro-concrete.

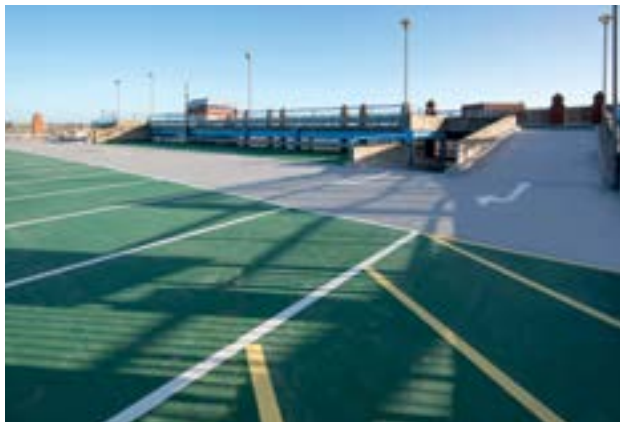
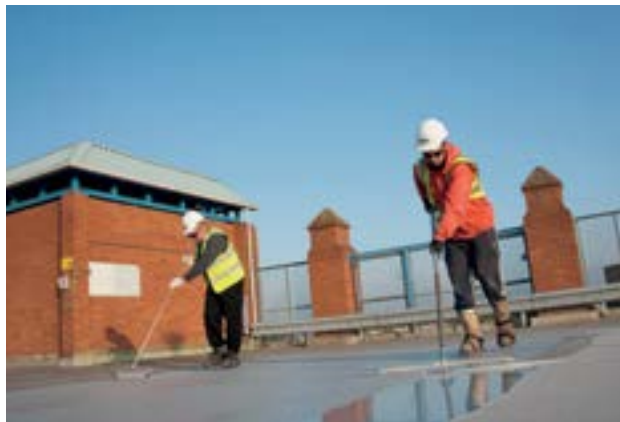
### SIKA HELPS RAPIDLY REPAIR UPPER HUNDREDS CAR PARK

Upper Hundreds MSCP is located in Aylesbury Town Centre with spaces for 305 vehicles. The car park, which is owned by Aylesbury District Council, was suffering from a failed waterproofing system on its top deck, allowing water ingress into the lower decks of the car park. This water ingress had caused spalling to the concrete screed, to the ramps and pedestrian walkways.

After further testing it was found that the concrete substrate did not have sufficient cohesive strength to support the application of a new car park deck system without further case hardening.

To remove existing failed coatings and concrete screed and repair damaged concrete on deck, ramps and soffits. Apply a case hardening resin to increase the cohesive strength of the concrete and apply a waterproof car park deck system, with fast setting properties, to prevent further water penetration and resulting damage.
